**Abbreviated Historic Resource Survey Form  
Pennsylvania Historical & Museum Commission**

Address: 701 Fairhill Avenue, Langhorne, PA 19047

Project Name: U.S. 1, Section RC3, Improvement Project Date: 11/11/2024

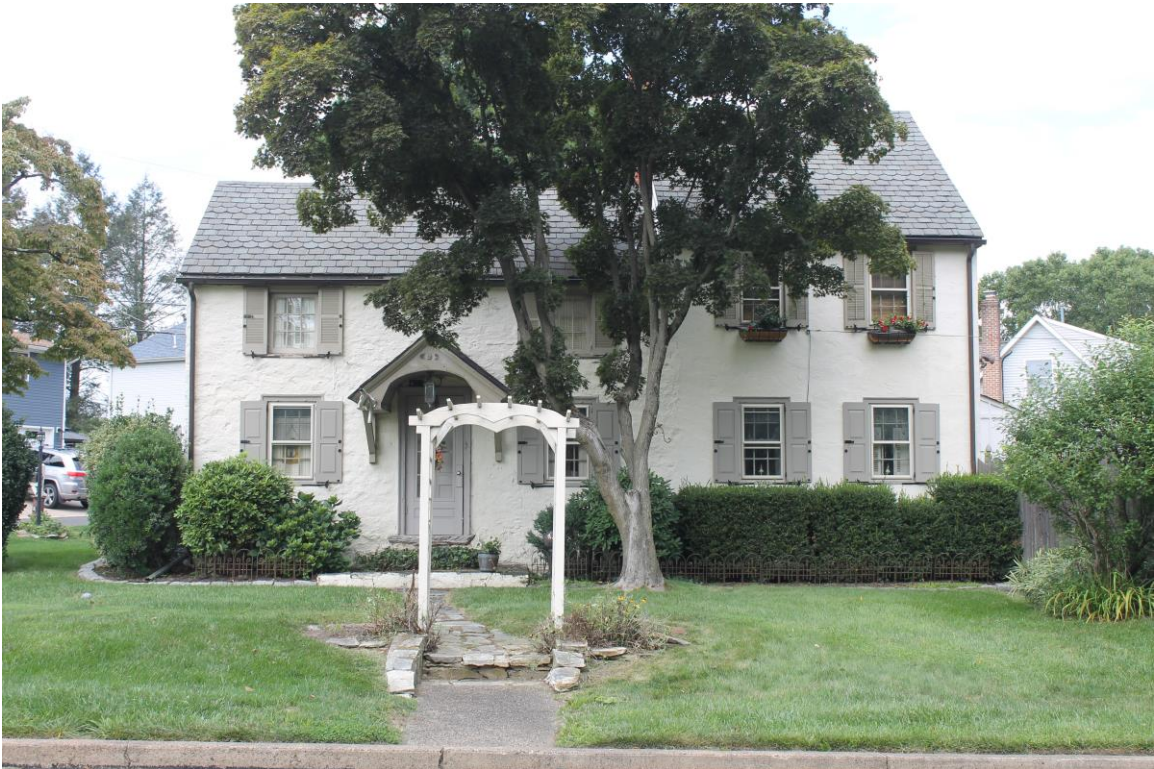
The southeast (primary) elevation has a two-paneled, wood door with a nine-light, wood storm door flanked on each side by a typical window with two-paneled wood shutters on the main block. The primary entrance is accessed via stone masonry steps, and is sheltered by an asphalt-shingled front-gable roof supported by wood brackets. Two typical windows with two-paneled wood shutters are located on the first story of the two-and-a-half-story addition, and a stained-glass window is located on the first story of the one-story addition. Two nine-light, wood casement windows with louvered wood shutters are on the second story of the main block, while two typical windows with louvered wood shutters are located on the second story of the two-and-a-half-story addition (Photograph 1).

Photograph 1: The southeast (primary) elevation of the pre-1890 dwelling (left) and pre-1938 addition (right), camera facing northwest (August 2024).

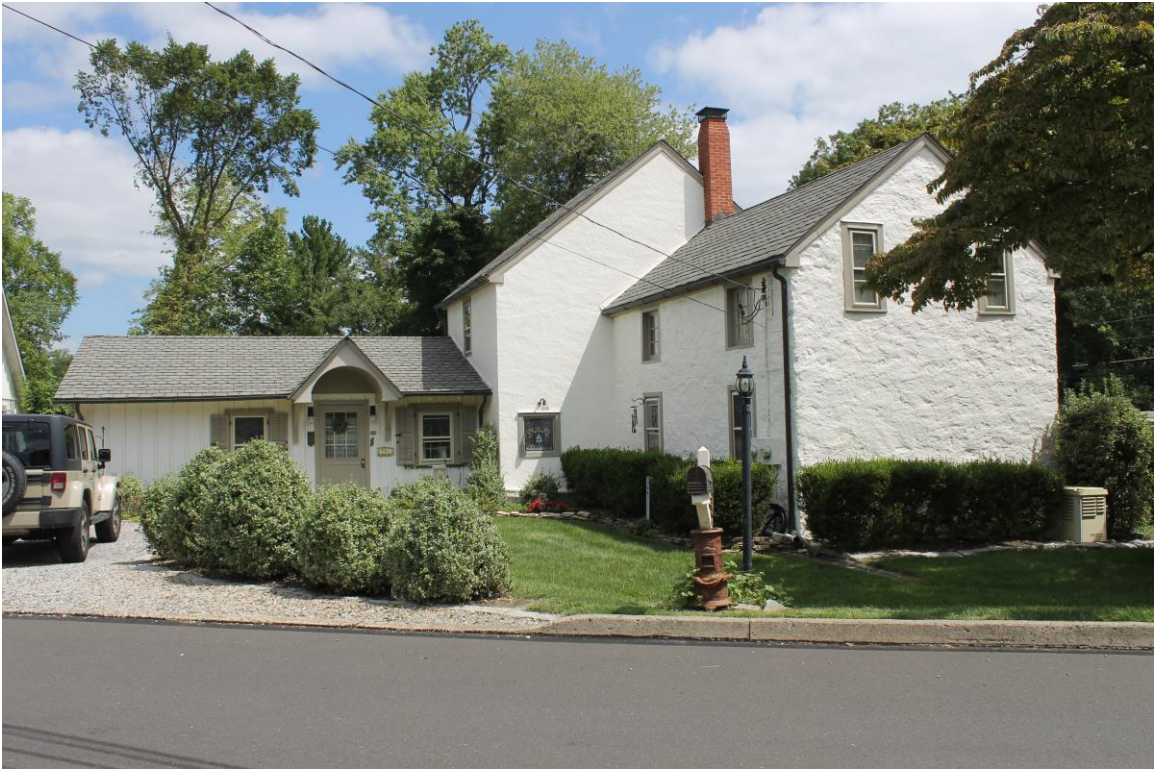
The southwest (side) elevation of the one-story addition contains a nine-light over two-panel wood door protected by a one-light over two-panel wood storm door. Typical windows with louvered wood shutters flank either side of the entrance. The entrance on the one-story addition is accessed via concrete walkway, and is sheltered by an asphalt shingled front-gable roof supported by wood brackets. A stained-glass window is on the first story of the two-and-a-half-story addition. The gable end of the main block contains two four-over-four, wood double-hung windows on the second story (Photograph 2).

Photograph 2: The southwest (side) elevation of the dwelling, camera facing northeast. Note the one-story addition and converted garage (left), the pre-1938 two-and-a-half-story addition (back middle), and the pre-1890 two-story main block of the dwelling (front right) shown here (August 2024).

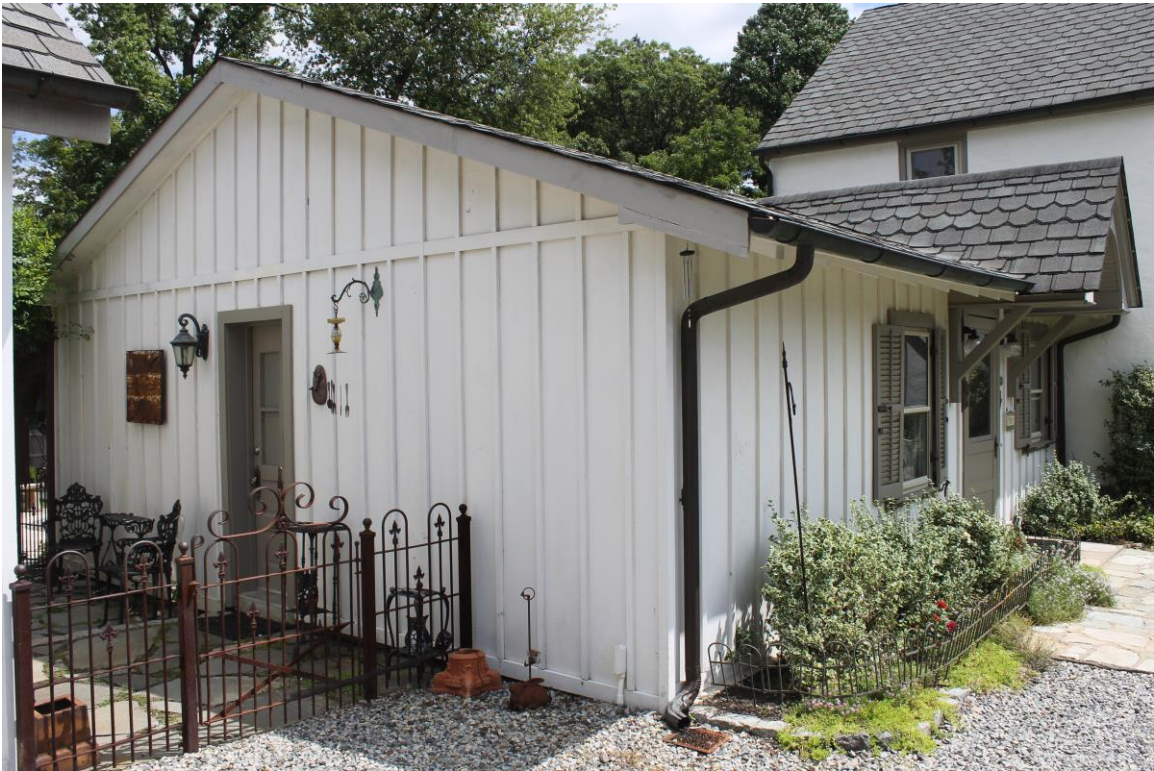
The northwest (rear) elevation of the one-story addition contains a four-light over two-panel wood door. Two typical windows are located on the first story of the main block of the dwelling, with two nine-light wood casement windows above them on the second story (Photographs 3-4). A typical window is located on the second story of the two-and-a-half-story addition.

Photograph 3: The northwest (rear) elevation of the dwelling, camera facing east. Note the one-story addition and converted garage (front left) and the pre-1938 two-and-a-half-story addition (back right) shown here (August 2023).

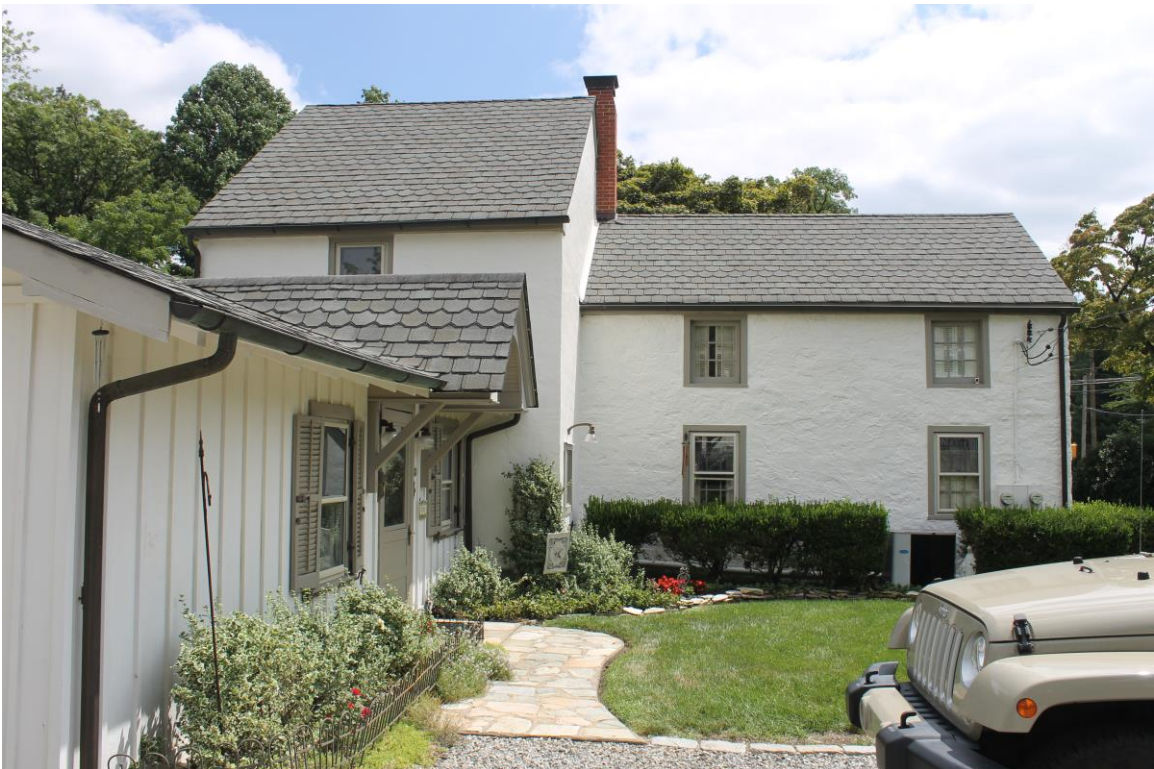
Photograph 4: The northwest (rear) of the dwelling showing the one-story addition and converted garage (front left), the pre-1938 two-and-a-half-story addition (back center), and the pre-1890 two-story main block of the dwelling (right) (August 2024).

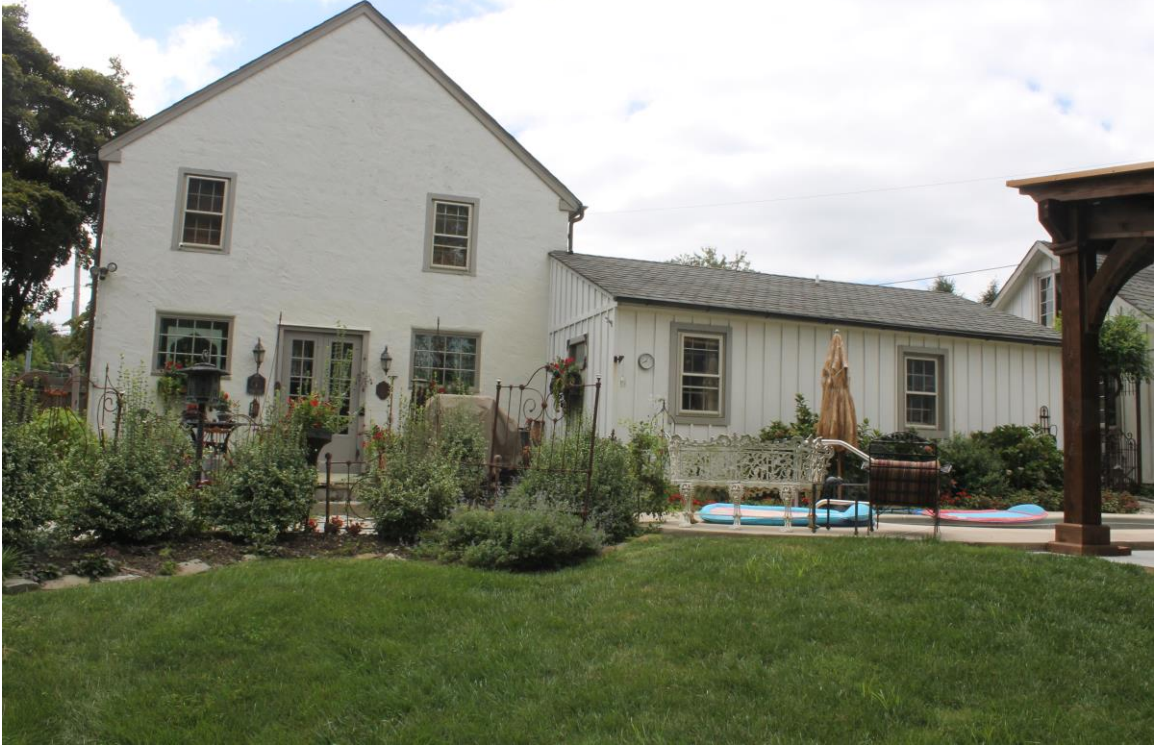
The northeast (side) elevation consists of the two-and-a-half-story addition and the one-story addition (Photograph 5). On the two-and-a-half-story addition, a pair of 10-light, wood French storm doors are flanked on each side by a 12-light, vinyl fixed window. Two typical windows are on the second story of the two-and-a-half-story addition, and two typical windows are on the one-story addition.

Photograph 5: The northeast (side) of the dwelling showing the pre-1938 two-and-a-half-story addition (left) and the one-story addition and converted garage (right), camera facing southwest (August 2024).

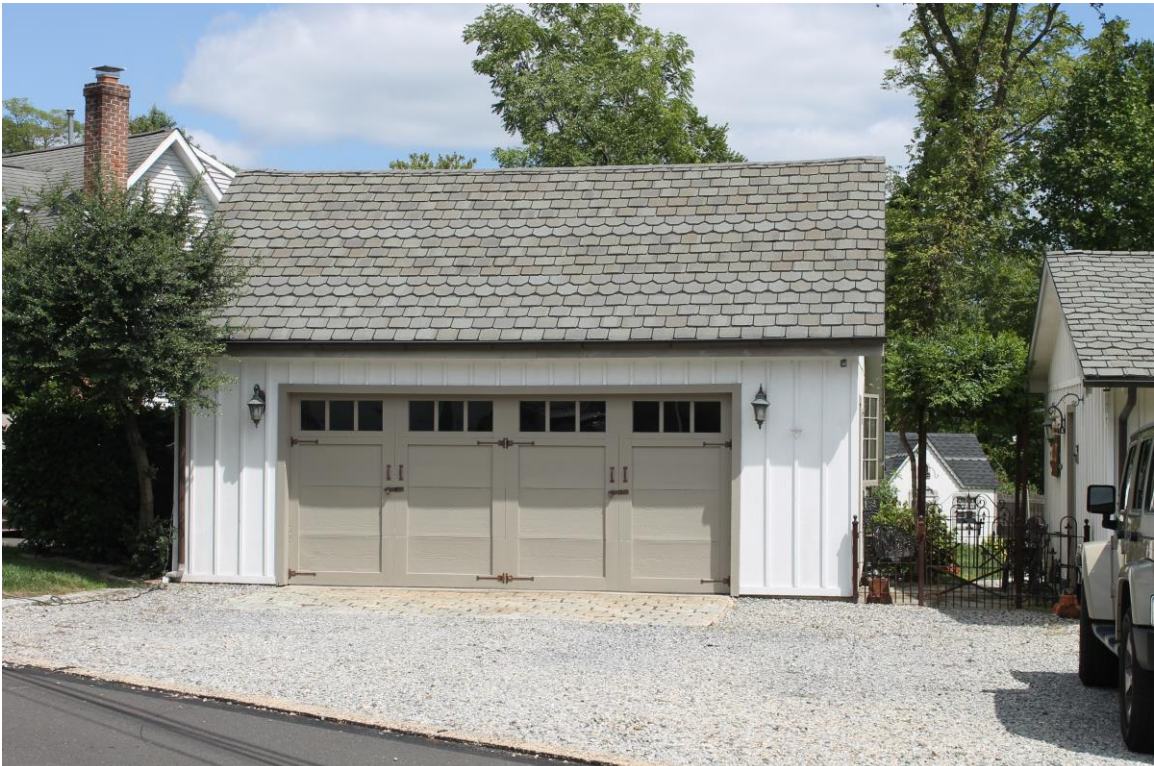
The 2003 garage is a one-story, two-bay garage with board and batten siding and a side gable roof clad in asphalt shingles (Photographs 6-9). The typical windows of the garage are eight-light, wood casement windows throughout unless otherwise noted. The southwest (primary) elevation contains two pairs of

Photograph 6: The southwest (primary) elevation of the 2003 garage, camera facing northeast (August 2024).

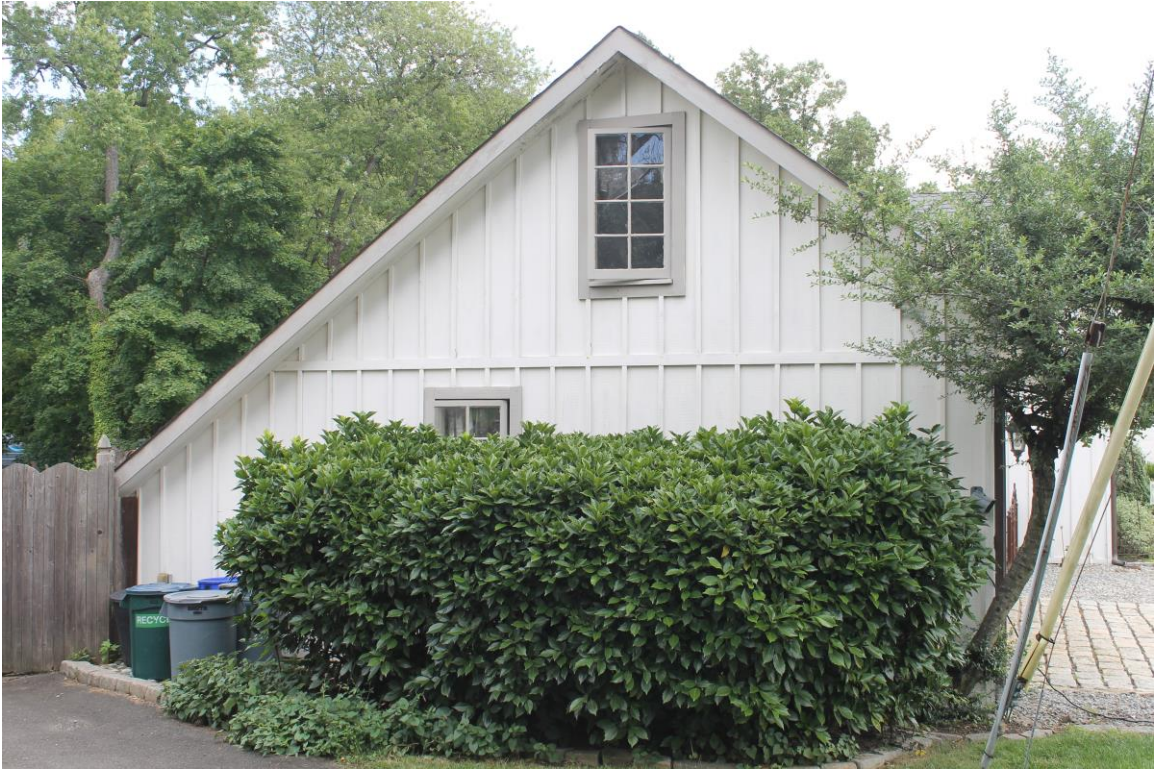
Photograph 7: The northwest (side) elevation of the 2003 garage, camera facing southeast (August 2024).

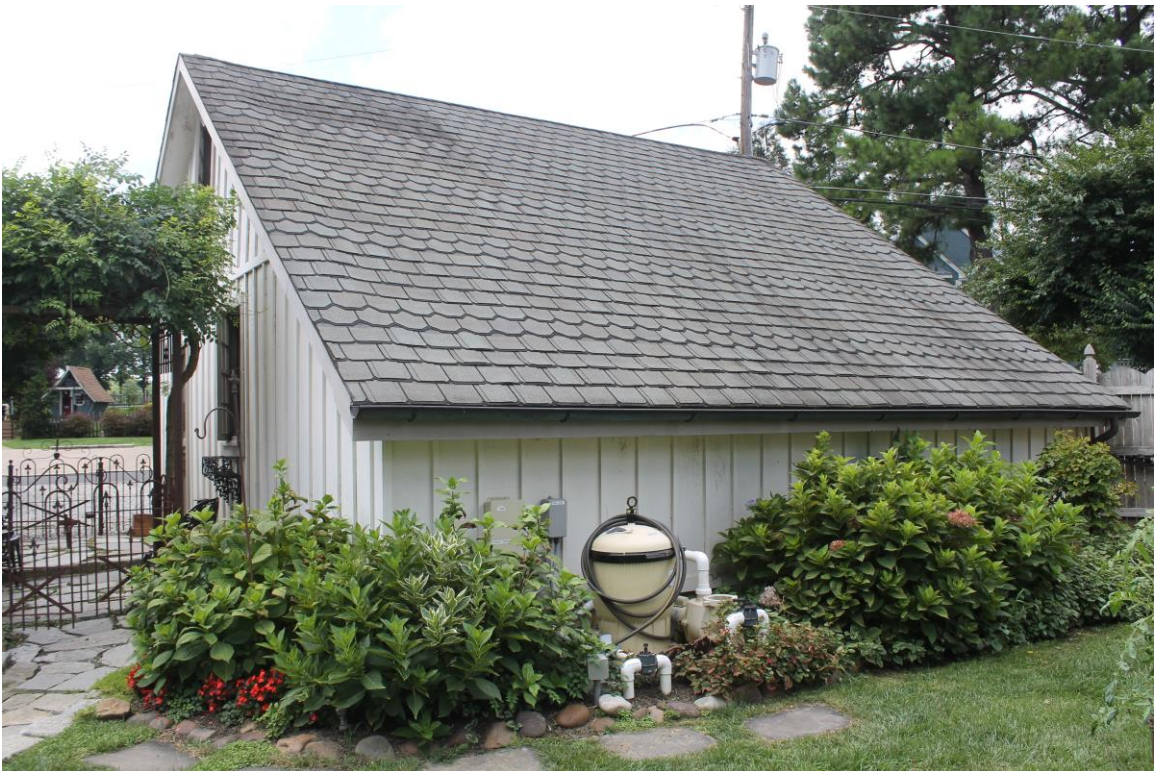
Photograph 8: The northeast (rear) elevation of the 2003 garage, camera facing west (August 2024).

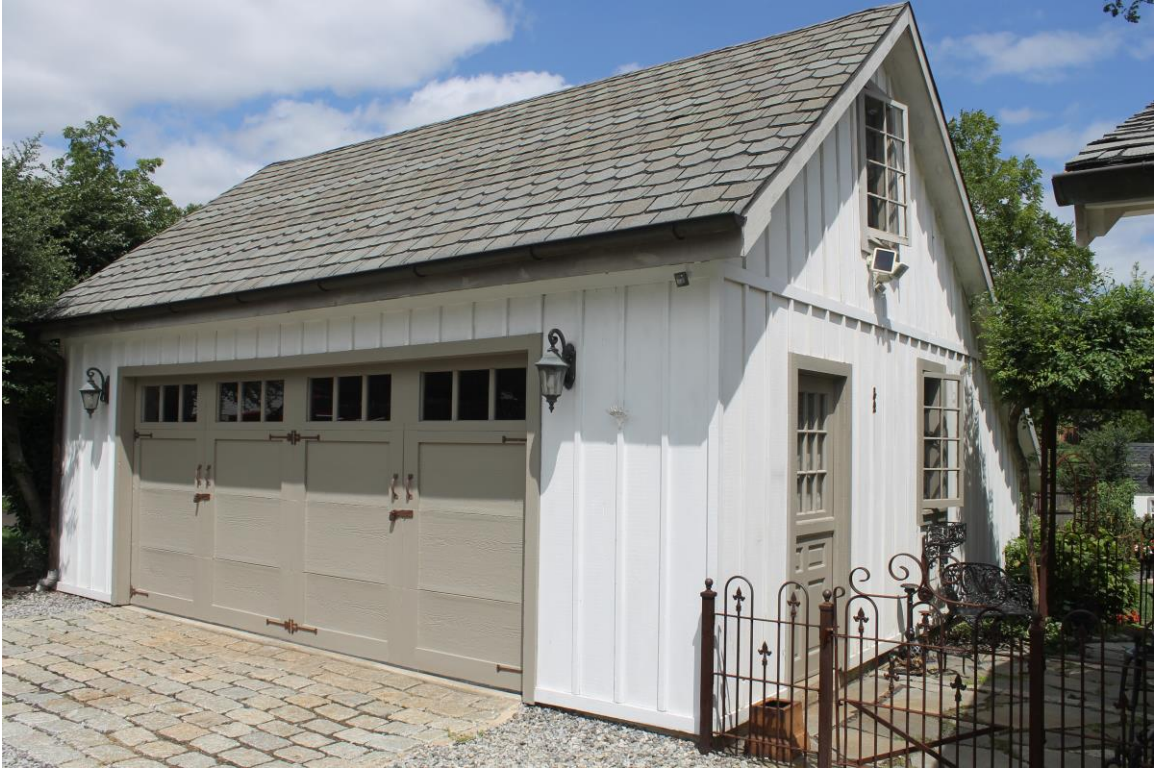
Photograph 9: The southwest (primary) and southeast (side) elevation of the 2003 garage, camera facing northeast (August 2024).

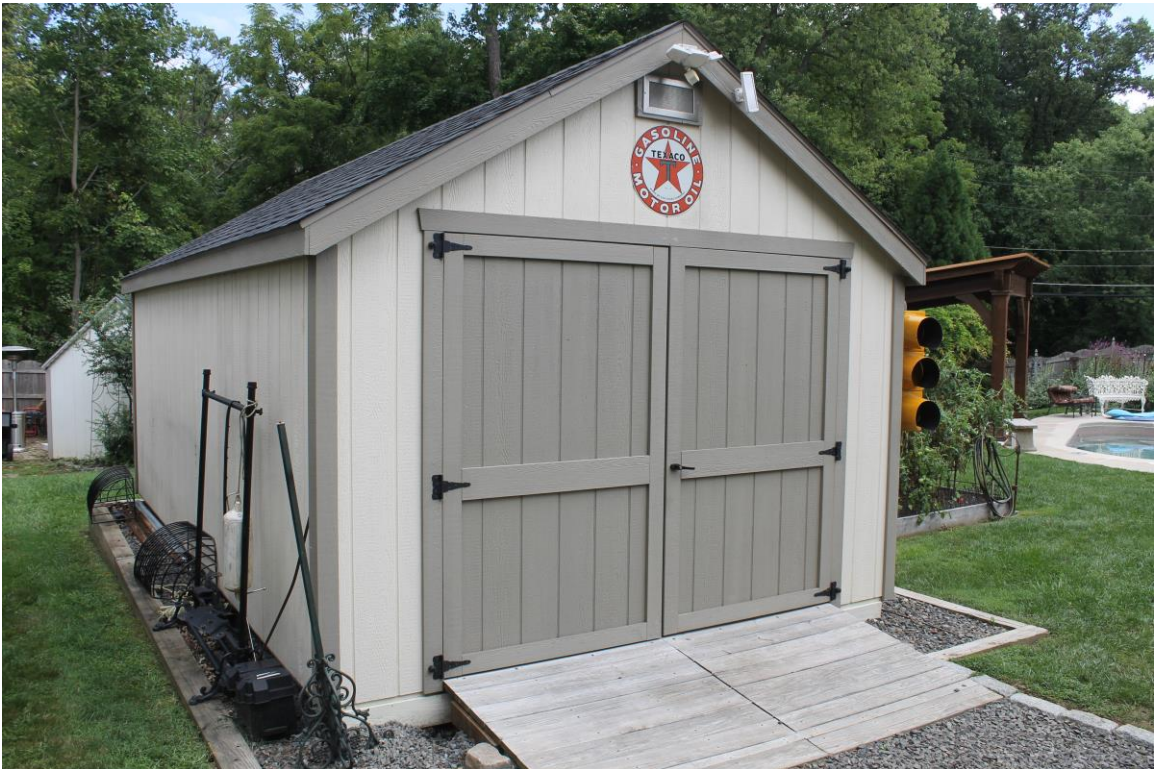
The modern storage shed, built sometime after 2019, is a pre-fabricated shed with T1-11 wood panel siding (Photographs 10-11). The southwest elevation contains a pair of wood doors, and the southeast elevation contains two modern vinyl windows; the northeast and northwest elevations do not have any fenestration. The gable roof is covered with asphalt shingles.

Photograph 10: The northwest (side) and southwest (front) elevations of the modern shed, camera facing east (August 2024).

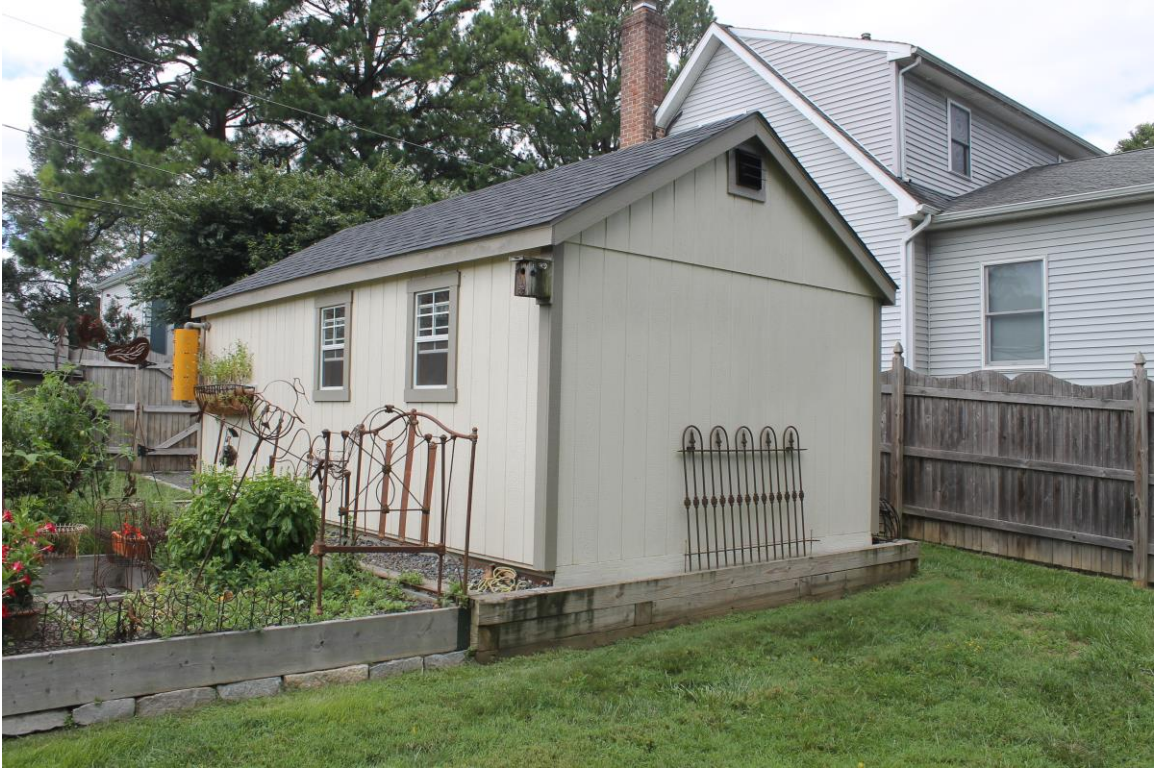
Photograph 11: The southeast (side) and northeast (rear) elevations of the modern shed, camera facing west (August 2024).

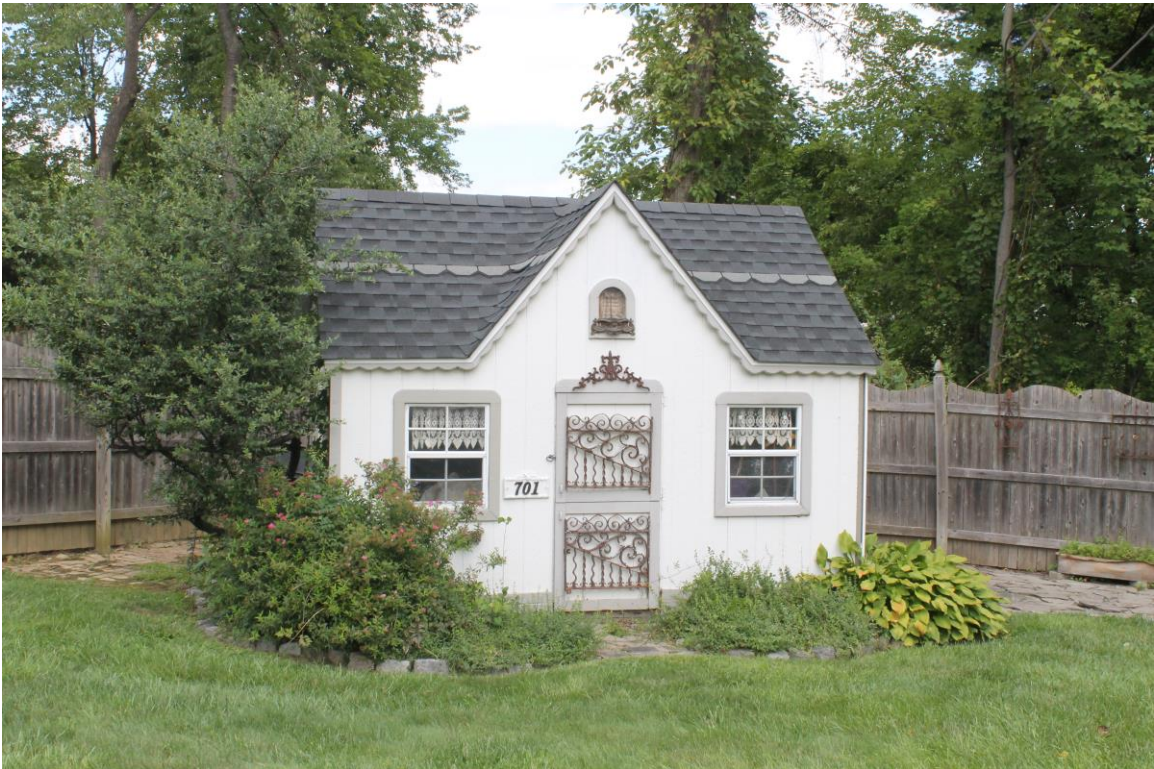
The modern playhouse, built sometime after 2010, is constructed of wood with a cross gable roof covered in asphalt shingles (Photographs 12-13). The southwest elevation contains a wood Dutch door that is flanked on either side by modern vinyl windows and the southeast elevation contains a wood swing door; the northwest and northeast elevations do not have any fenestration.

Photograph 12: The southwest (front) elevation of the modern playhouse, camera facing northeast (August 2024).

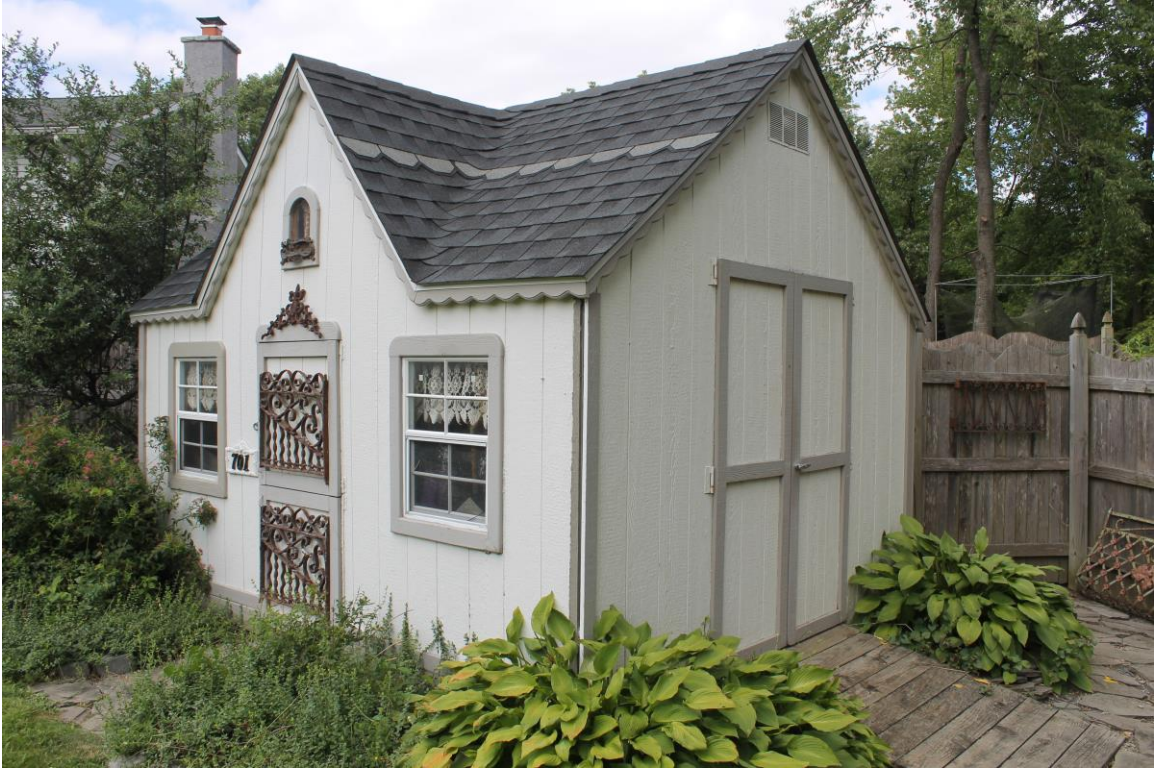
Photograph 13: The southwest (front) and southeast (side) elevations of the modern playhouse, camera facing northwest (August 2024).
