AQUATIC RESOURCE IDENTIFICATION & DELINEATION REPORT

SR 0001 Section RC3 Improvement Project (MPMS # 93446) Langhorne and Langhorne Manor Boroughs, and Middletown Township Bucks County, Pennsylvania

JMT Project #: 00-0285-005

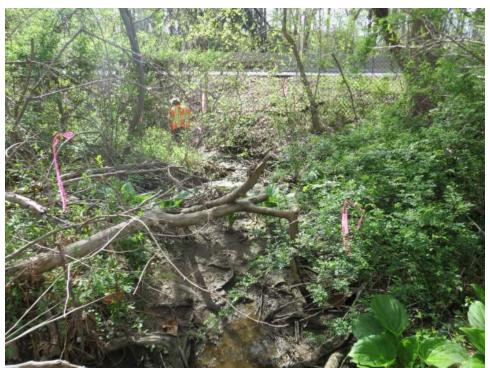
Photo 1: Looking southeast (downstream) along WUS-9 to the north of SR 0001, near the northeastern end of the study area. Photo taken April 19, 2021.

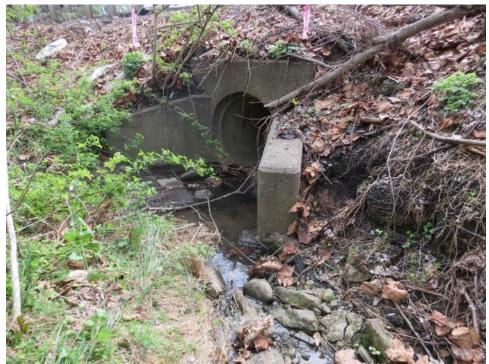
Photo 2: Looking east (downstream) along WUS-9 towards the headwall of the culvert crossing beneath SR 0001, in the northeastern portion of the study area. Photo taken April 19, 2021.

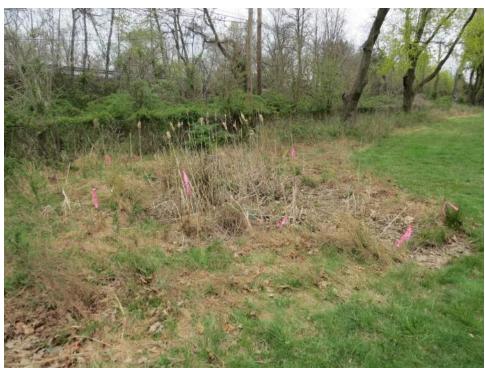
Photo 5: Looking northwest towards Wetland E (WET-E), located north of SR 0001 and east of SR 0413, in the northeastern portion of the study area.

Wetland E (WET-E) is a PEM wetland approximately 0.004 acres in size and is located north of SR 0001 and east of SR 0413 (Pine Street) (see **Photo 5** in **Appendix D**). This wetland consists of a small, shallow depression located at the edge of a maintained field. Hydrology in WET-E is supplied primarily by a seasonally high water table and surface/roadway runoff. Wetland hydrology indicators observed for WET-E included surface water, saturation (episaturation), water-stained leaves, geomorphic position, microtopographic relief, and the FAC-Neutral Test, which satisfied the wetland hydrology parameter. Vegetation within the TP-1 sample plot was dominated by soft rush (FACW), broad-leaf cattail (*Typha latifolia, OBL*), and path rush (*Juncus tenuis*, FAC). The hydrophytic vegetation parameter was met by the dominance test indicator. The soil sample from TP-1 featured a clay texture with a 10 YR 5/2 matrix and 10YR YR 6/8 redoximorphic features between 0 and 10 inches in depth. This soil characterization fulfills the hydric soil parameter as defined by Indicator F3 (Depleted Matrix). Based on these reasons, WET-E was delineated as a jurisdictional wetland.

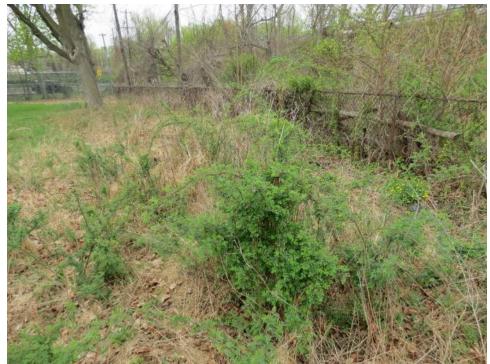
Photo 6: Looking south towards the TP-2 upland sample plot located to the south of Wetland E (WET-E), in the northeastern portion of the study area. Photo taken April 19, 2021.

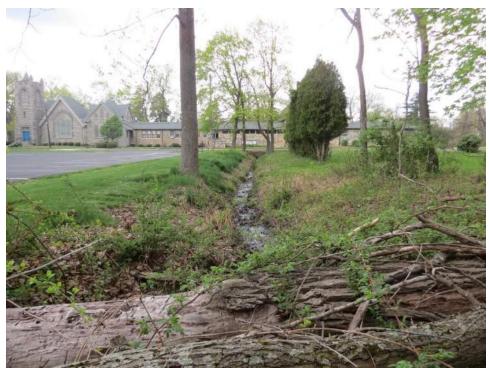
Photo 9: Looking northwest (upstream) along WUS-3, to the north of SR 0001 and east of South Bellevue Avenue. Photo taken April 19, 2021.

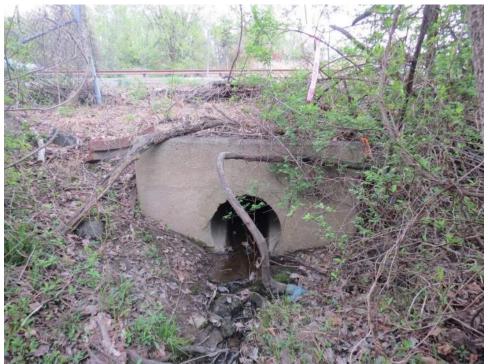
Photo 10: Looking southeast (downstream) along WUS-3 towards the pipe headwall on the northern side of SR 0001. Photo taken April 19, 2021.

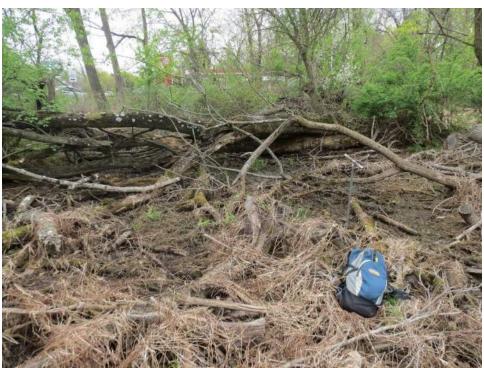
Photo 11: Looking southwest towards the TP-3 sample plot within Wetland 1 (WET-1), to the north of SR 0001 and east of South Bellevue Avenue. Photo taken April 19, 2021.

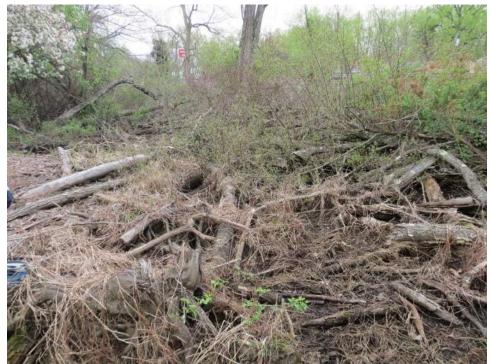
Photo 12: Looking east towards the eastern side of Wetland 1 (WET-1), to the north of SR 0001 and east of South Bellevue Avenue. Photo taken April 19, 2021.

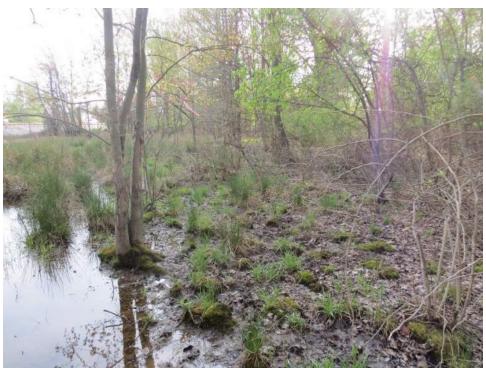
Photo 13: Looking southwest towards the TP-4 sample plot within Wetland 2 (WET-2), to the north of SR 0001 and west of SR 0413 (S. Pine Street). Photo taken April 19, 2021.

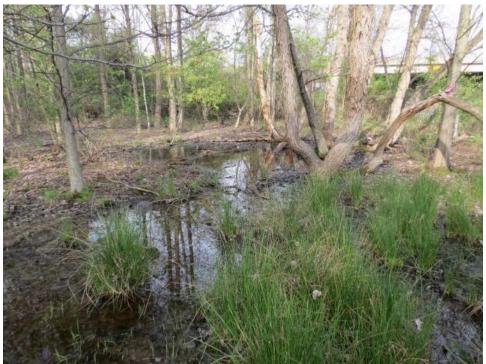
Photo 14: Looking east towards Wetland 2 (WET-2), to the north of SR 0001 and west of SR 0413 (S. Pine Street). Photo taken April 19, 2021.

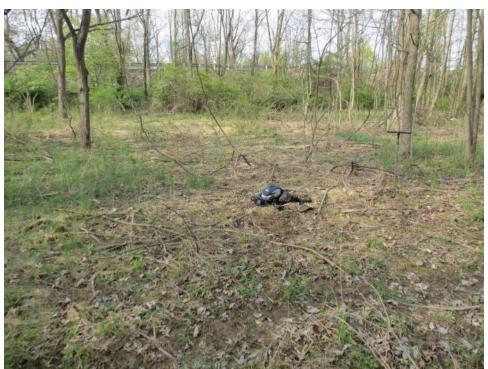
Photo 15: Looking northwest towards the TP-5 upland sample plot, located to the north of Wetland 2 (WET-2). Photo taken April 19, 2021.

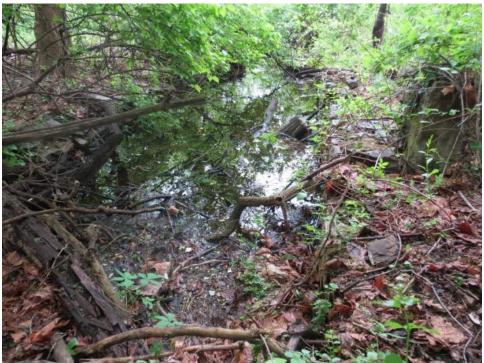
Photo 18: Looking south (downstream) along WUS-8, north of SR 0001 and south of SR 2045 (Old Lincoln Highway) in the southwestern portion of the study area. Photo taken May 4, 2021.

Waters of the U.S. 8 (WUS-8) is an intermittent UNT to Neshaminy Creek Cowardin classification = R4SB3) that generally flows in a southerly direction and is located inside a roadway ramp depression in the southwestern portion of the study area (see **Photo 18** in **Appendix D**). The average stream width was approximately 5 to 6 feet upstream and 2 to 3 feet downstream, and the water depth was generally 2 to 4 inches. Observed substrate consisted of a mix of silt/sand and gravel. Natural bank heights ranged from 0.5 to 1 feet, with some areas being lined with concrete walls. The riparian area consisted of a mix of trees and shrubs.

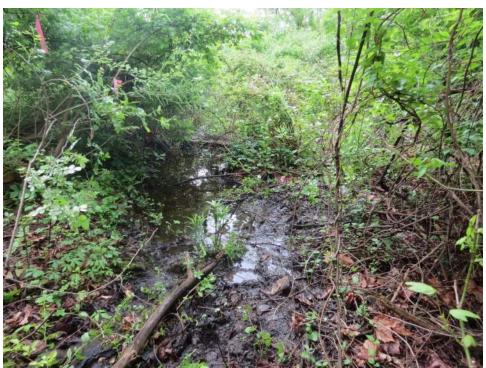
Photo 19: Looking northwest towards the TP-6 sample plot within Wetland A (WET-A), located to the west of WUS-8 in the southwestern portion of the study area. Photo taken May 4, 2021.

Wetland A (WET-A) is a small PEM wetland approximately 0.005 acres in size, located in a depression north of SR 0001 near the southwestern end of the study area (see **Photo 19** in **Appendix D**). This wetland discharges into WUS-8. Hydrology in WET-A is primarily supplied by a seasonally high water table, high flows from WUS-8, and roadway/surface runoff. Wetland hydrology indicators observed for WET-A included surface water, a high water table, saturation, water-stained leaves, and geomorphic position. Vegetation within the TP-6 sample plot was dominated by poison ivy (*Toxicodendron radicans*, FAC) and red maple (FAC) saplings. The hydrophytic vegetation parameter was met by the dominance test indicator. The soil sample from TP-6 featured a silt loam texture with a 10 YR 2/1 matrix between 0 and 4 inches in depth, and a 10 YR 3/2 matrix with 7.5 YR 5/6 redoximorphic features from 4 to 14 inches in depth. This soil characterization fulfills the hydric soil parameter as defined by Indicator F6 (Redox Dark Surface). Based on these reasons, WET-A was delineated as a jurisdictional wetland.

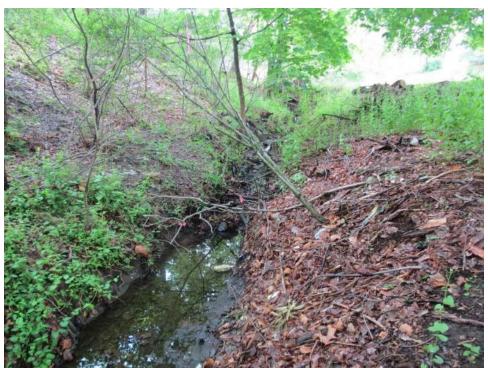
Photo 23: Looking south (upstream) along WUS-7, located north of SR 0001 and east of SR 2008 (Highland Avenue). Photo taken May 4, 2021.

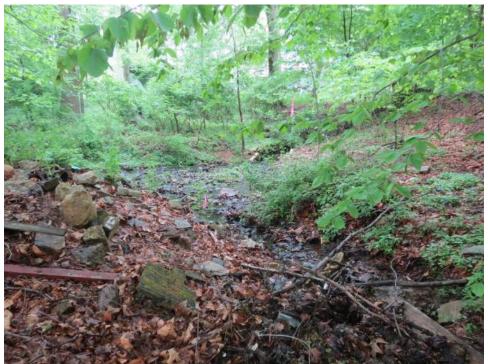
Photo 24: Looking northeast (downstream) along WUS-7 towards its confluence with WUS-6, to the north of SR 0001 and east of SR 2008 (Highland Avenue). Photo taken May 4, 2021.

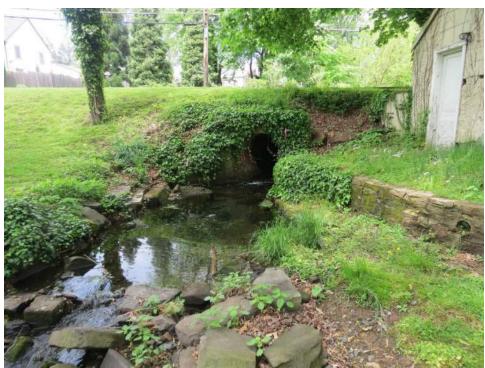
Photo 25: Looking northwest (upstream) along WUS-6, towards the culvert crossing beneath SR 2045 (Old Lincoln Highway). Photo taken May 4, 2021.

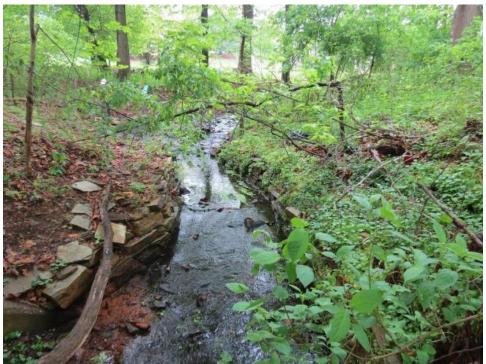
Photo 26: Looking west (upstream) along WUS-6, from just upstream of the SR 0001 culvert crossing. Photo taken May 4, 2021.

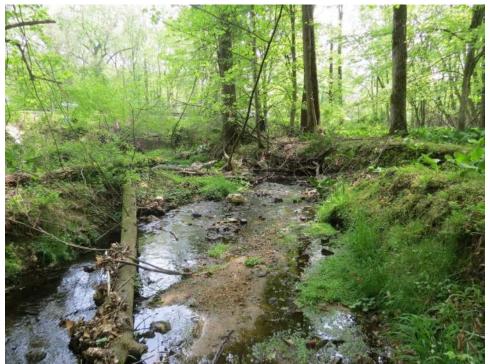
Photo 32: Looking southwest (downstream) along WUS-4 in woodlands located north of SR 0001 in the central portion of the study area. Photo taken May 4, 2021.

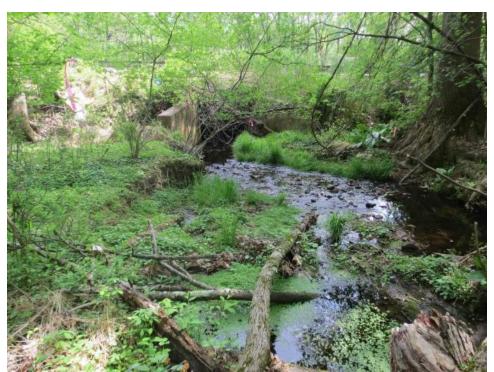
Photo 33: Looking south (downstream) along WUS-4 in woodlands located north of SR 0001 in the central portion of the study area. Photo taken May 4, 2021.

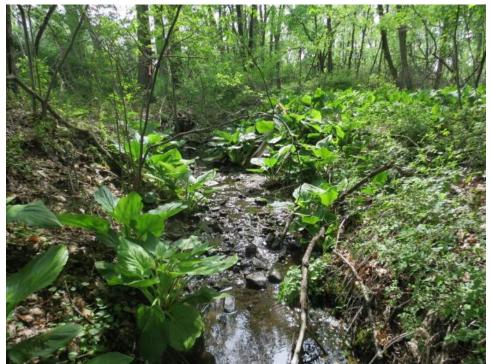
Photo 34: Looking southwest (upstream) along WUS-5, located west of WUS-4 in the central portion of the study area. Photo taken May 4, 2021.

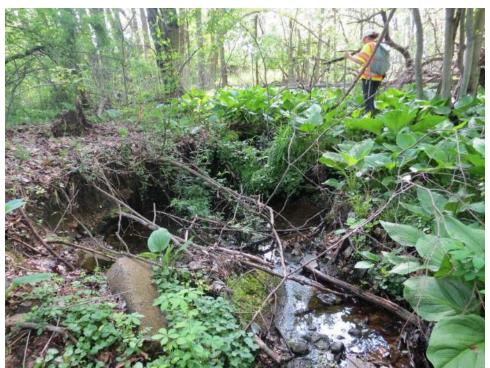
Photo 35: Looking west (upstream) along WUS-5 towards the point where it emanates from Wetland 3 (WET-3). Photo taken May 4, 2021.

Wetland 3 (WET-3) is a PFO wetland located in the central portion of the study area, north of SR 0001 (see **Photos 35** and **37-38** in **Appendix D**). The delineated portion of the wetland was approximately 0.188 acres in size. This wetland was delineated as open-ended and continues further north outside the study area. Hydrology in WET-3 is primarily supplied by groundwater springs/seeps, a seasonally high water table, high flows from adjacent streams, and roadway/surface runoff. Wetland hydrology indicators observed for WET-

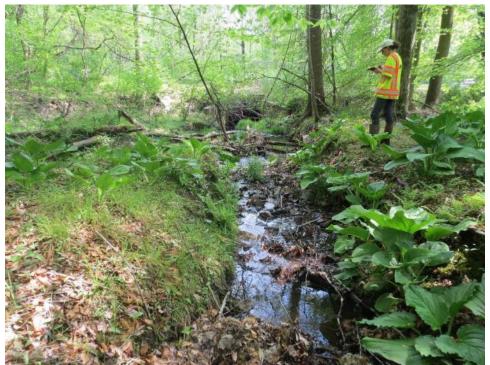
Photo 36: Looking southeast (downstream) along WUS-10 towards its confluence with WUS-4. Photo taken May 4, 2021.

Waters of the U.S. 10 (WUS-10) is an intermittent UNT to Neshaminy Creek (Cowardin classification = R4SB3) that generally flows in a southeasterly direction alongside WET-3 before discharging into WUS-4 (see **Photo 36** in **Appendix D**). The average stream width was approximately 3 to 5 feet and the water depth was generally 1 to 2 inches. Observed substrate consisted of a mix of silt/sand, gravel, and cobble rock. Bank heights averaged 2 feet, with some areas being moderately incised. The riparian area consisted of a mix of trees and shrubs.

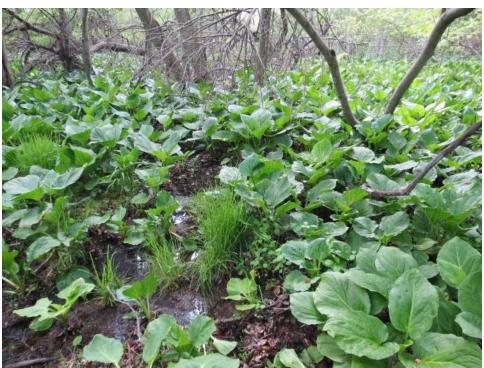
Photo 37: Looking northwest towards the TP-9 sample plot located within Wetland 3 (WET-3). Photo taken May 4, 2021.

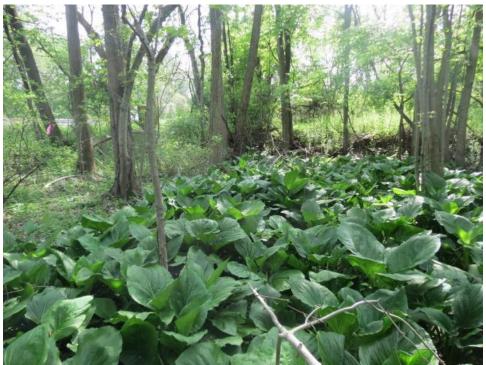
Photo 38: Looking southwest towards the western side of Wetland 3 (WET-3). Photo taken May 4, 2021.

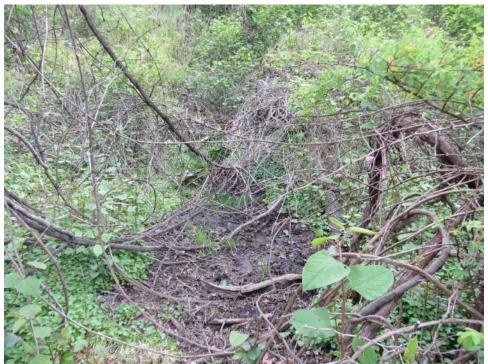
Photo 40: Looking east towards Wetland B (WET-B), which is located north of SR 0001 on the west side of the West Interchange Road roadway embankment. Photo taken May 4, 2021.

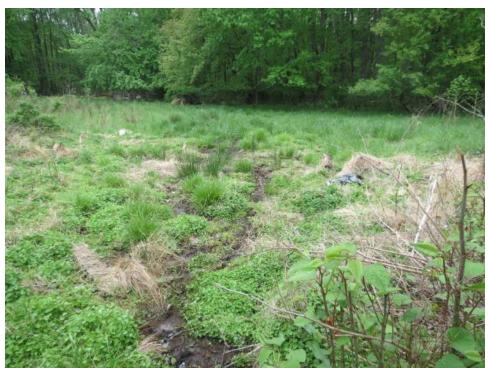
Photo 41: Looking southwest towards the TP-11 sample plot within Wetland B (WET-B). Photo taken May 4, 2021.

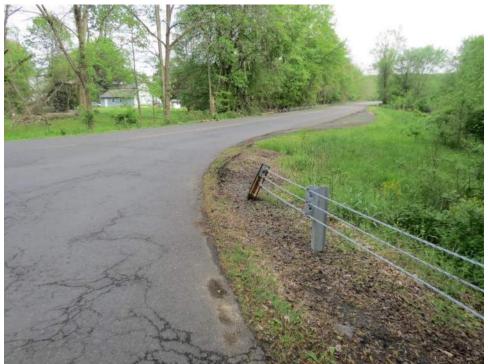
Photo 43: Looking west (downstream) along WUS-11, located at the northern end of West Interchange Road. Photo taken May 4, 2021.

Waters of the U.S. 11 (WUS-11) is an intermittent UNT to Neshaminy Creek (Cowardin classification = R4SB3) that generally flows in a westerly direction and is located to the south of West Gillam Avenue and west of West Interchange Road (see **Photos 43** and **85** in **Appendix D**). This watercourse discharges into Waters of the U.S. 17 (WUS-17). The average stream width was approximately 4 to 5 feet and the water depth was generally 2 to 4 inches. Observed substrate consisted of a mix of silt/sand, gravel, and cobble rock. Bank heights ranged from 3 to 5 feet, with some areas being heavily incised. The riparian area consisted of a mix of trees and shrubs.

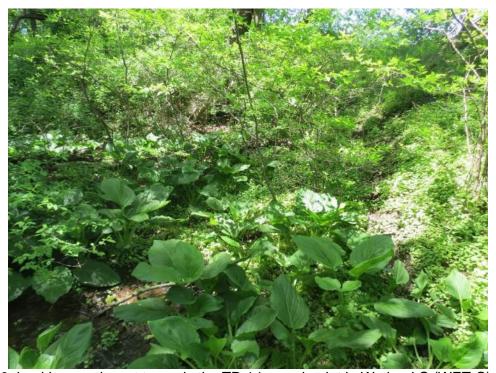
Photo 60: Looking southwest towards the TP-14 sample plot in Wetland C (WET-C), located south of SR 0001 in the central portion of the study area. Photo taken May 11, 2021.

Wetland C (WET-C) is a PSS wetland located south of SR 0001 and west of WUS-4 (see **Photo 60** in **Appendix D**). The delineated portion of the wetland was approximately 0.027 acres in size. This wetland was delineated as open-ended and continues further south outside the study area. Multiple narrow fingers fed by groundwater seepage were observed in the vicinity of the study area. Hydrology in WET-C is primarily supplied by groundwater springs/seeps, a seasonally high water table, and roadway/surface runoff. Wetland hydrology indicators observed for WET-C included surface water, high water table, saturation, iron deposits, water-stained leaves, drainage patterns, geomorphic position, and the FAC-Neutral Test, which satisfied the wetland hydrology parameter. Vegetation within the TP-14 sample plot was dominated by northern spicebush (FAC), skunk cabbage (OBL), lesser celandine (FAC), and jewelweed (*Impatiens capensis*, FACW). The hydrophytic vegetation parameter was met by the dominance test indicator. The soil sample from TP-14 featured mucky (sapric) organic soils with a 10 YR 2/1 matrix and some depleted 10 YR 4/2 mineral soils between 0 and 8 inches in depth, and a 10 YR 3/2 matrix from 8 to 12 inches in depth. This soil characterization fulfills the hydric soil parameter as defined by Indicator A2 (Histic Epipedon). Based on these reasons, WET-C was delineated as a jurisdictional wetland.

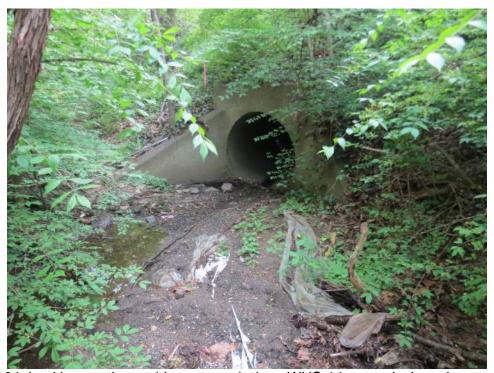
Photo 64: Looking southwest (downstream) along WUS-14, towards the culvert crossing beneath West Interchange Road. Photo taken May 11, 2021.

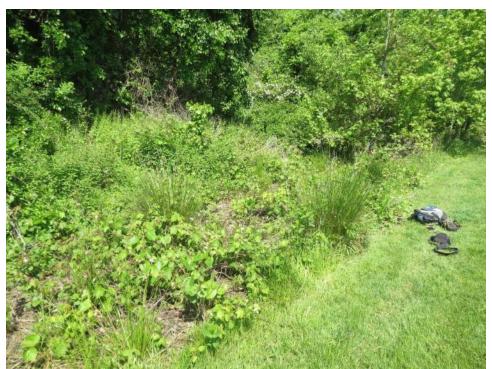
Photo 72: Looking west towards the TP-16 sample plot within Wetland D (WET-D), located east of SR 0413 (Pine Street) and south of Woods Drive. Photo taken May 19, 2021.

Wetland D (WET-D) is a PEM wetland approximately 0.133 acres in size and is located south of SR 0001 and east of SR 0413 (Pine Street) (see **Photo 72** in **Appendix D**). Hydrology in WET-D is supplied primarily by a seasonally high water table and surface/roadway runoff. Wetland hydrology indicators observed for WET-D included oxidized rhizospheres on living roots, geomorphic position, and the FAC-Neutral Test, which satisfied the wetland hydrology parameter (the wetland was primarily dry during the delineation). Vegetation within the TP-16 sample plot was dominated by common reed (*Phragmites australis*, FACW). The hydrophytic vegetation parameter was met by the rapid test and dominance test indicators. The soil sample from TP-16 featured a silt loam texture with a 10 YR 4/2 matrix between 0 and 2 inches in depth, a clay loam texture with a 10 YR 4/3 matrix and 10YR 4/6 redoximorphic features from 2 to 7 inches in depth, and a silty clay loam texture with a 10 YR 2/2 matrix and 7.5 YR 4/6 redoximorphic features from 7 to 14 inches in depth. This soil characterization fulfills the hydric soil parameter as defined by Indicator F6 (Redox Dark Surface). Based on these reasons, WET-D was delineated as a jurisdictional wetland.

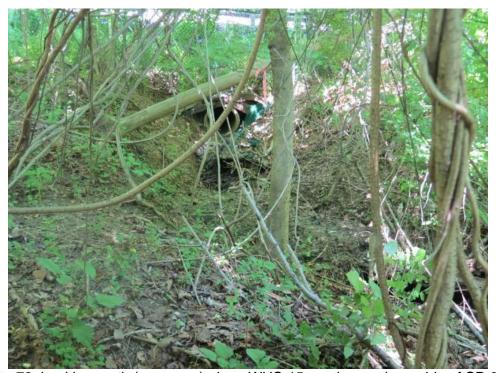
Photo 77: Looking northwest (upstream) along WUS-9 towards the culvert crossing beneath SR 0001. Photo taken May 19, 2021.

Waters of the U.S. 9 (WUS-9) is an intermittent UNT to Mill Creek (Cowardin classification = R4SB3/4) that generally flows in a southeasterly direction beneath SR 0001 near the northeastern end of the study area (see **Photos 1-2, 77,** and **83** in **Appendix D**). The average stream width was approximately 2.5 feet to the north of SR 0001 and 8-10 feet south of SR 0001, and the water depth was generally 1 to 3 inches. Observed substrate consisted of a mix of silt/sand, gravel, and cobble rock. Bank heights ranged from 3 to 5 feet, with some areas being heavily incised and stabilized by rock and gabions. The riparian area consisted of a mix of trees and shrubs.

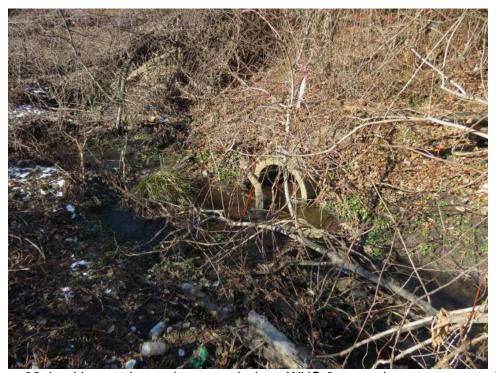
Photo 82: Looking northwest (upstream) along WUS-2, towards a stormwater pipe outfall that drains into the watercourse. Photo taken January 11, 2022.

Waters of the U.S. 2 (WUS-2) is an intermittent UNT to Mill Creek (Cowardin classification = R4SB3) that generally flows in a southeasterly direction along the western side of SR 0413 (Pine Street), to the south of SR 0001 (see **Photos 68-70, 74,** and **81-82** in **Appendix D**). This watercourse is then piped beneath SR 0413 just south of Central Avenue and continues northeast along the southern side of Woods Drive. The average stream width was approximately 5 to 6 feet and the water depth was generally 1 to 3 inches. Observed substrate consisted of a mix of silt/sand, gravel, and sparse cobble rock. Bank heights ranged from 0.5 to 1 foot, with very little areas being incised, and the riparian area consisted of a mix of trees and shrubs.

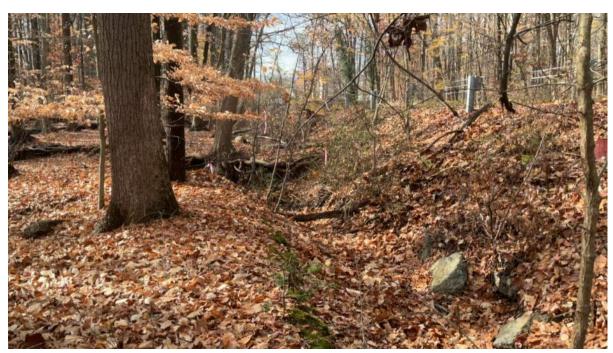
Photo 85: Facing west (downstream) along WUS-11 toward its confluence with WUS-17 in the central portion of the study area. Photo taken November 26, 2024.

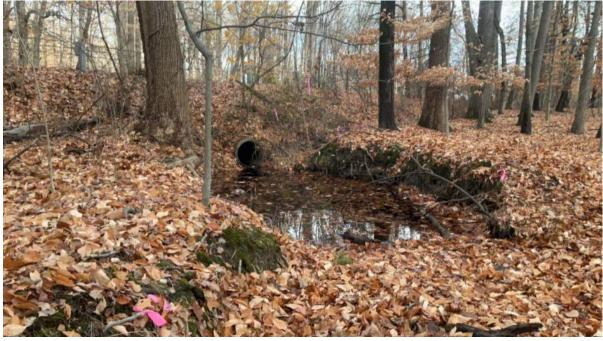
Photo 86: Facing northeast (upstream) along WUS-17 in the central portion of the study area. Photo taken November 26, 2024.

Waters of the U.S. 17 (WUS-17) is a perennial UNT to Neshaminy Creek (Cowardin classification = R5UB1) that generally flows in a southwesterly direction and emanates from an outfall pipe beneath West Gillam Avenue (see **Photo 86** in **Appendix D**). The average stream width was approximately 10 to 15 feet and water depth ranged from 8 to 12 inches. Observed substrate consisted primarily of silt/sand, gravel, cobble, and sparse boulders. Bank heights averaged 3 feet and were moderately incised, and the riparian area

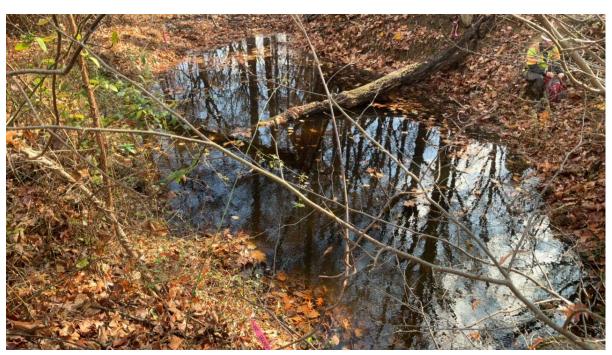
Photo 87: Facing southeast (downstream) along WUS-18 in the central portion of the study area. Photo taken November 26, 2024.

Waters of the U.S. 18 (WUS-18) is a perennial UNT to Neshaminy Creek (Cowardin classification = R5UB1) that generally flows in a southeasterly direction and emanates from an outfall pipe beneath West Gillam Avenue (see **Photo 87** in **Appendix D**). The average stream width was approximately 10 to 20 feet and water depth was 6 to 30 inches. Observed substrate consisted primarily of silt/sand, gravel, and cobble. Bank heights averaged 2 to 6 feet and were moderately to heavily incised, and the riparian area consisted of a mix of trees and shrubs.

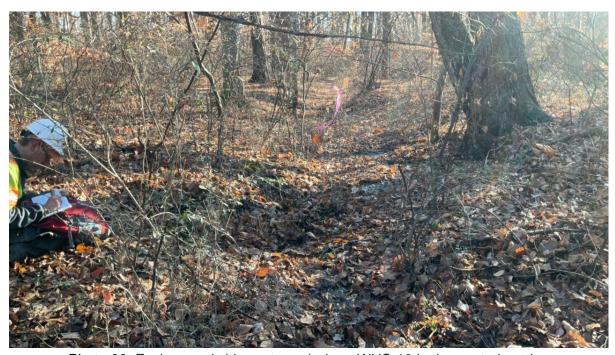
Photo 88: Facing south (downstream) along WUS-19 in the central portion of the study area. Photo taken November 26, 2024.

Waters of the U.S. 19 (WUS-19) is an intermittent UNT to Neshaminy Creek (Cowardin classification = R4SB4) that generally flows in a southwesterly direction along W Highland Avenue and south towards its confluence with WUS-4 (see **Photos 88-89** in **Appendix D**). The average stream width was approximately 2 to 4 feet and surface water was observed from 0 to 1 inches at the time of the field investigation. Observed substrate consisted primarily of silt/sand with sparse gravel and cobble. Bank heights averaged 0.5 to 1.5 feet and the riparian area consisted of a mix of trees and shrubs. It was noted that the channel was covered in leaf litter, with hydric soils evident.

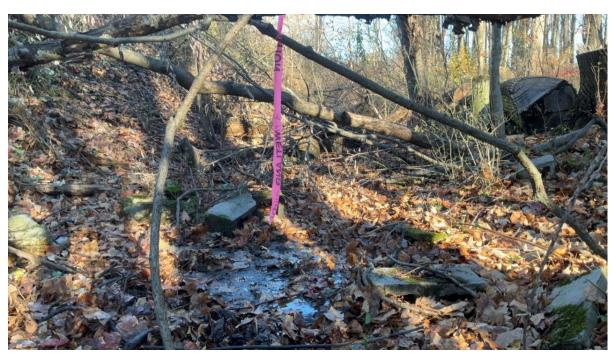
Photo 89: Facing northeast (upstream) along WUS-19 in the central portion of the study area. Photo taken November 26, 2024.

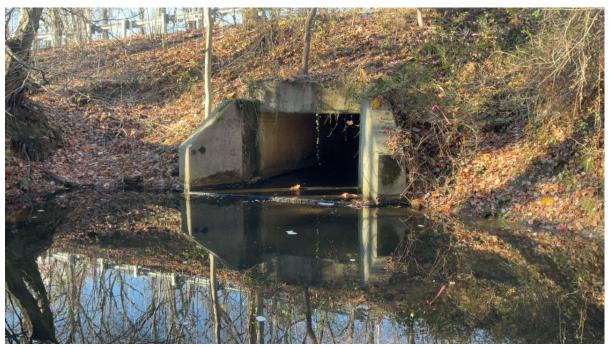
Photo 90: Facing northwest (upstream) along WUS-4 toward the culvert under West Highland Avenue in the central portion of the study area. Photo taken November 26, 2024.

Waters of the U.S. 4 (WUS-4) is a perennial UNT to Neshaminy Creek (Cowardin classification = R5UB1H) that generally flows in a southeasterly direction beneath SR 0001, within woodlands located between SR 2027 (Hulmeville Road) and West Interchange Road (see **Photos 32-33**, **58**, and **90** in **Appendix D**). The stream width was approximately 12 to 45 feet and the water depth was generally 2 to 12 inches with some deeper pools. Observed substrate consisted of a mix of silt/sand, gravel, cobble rock, and sparse boulders. Bank heights ranged from 2 to 8 feet, with some areas being moderately to heavily incised. The riparian area consisted of a mix of trees and shrubs.

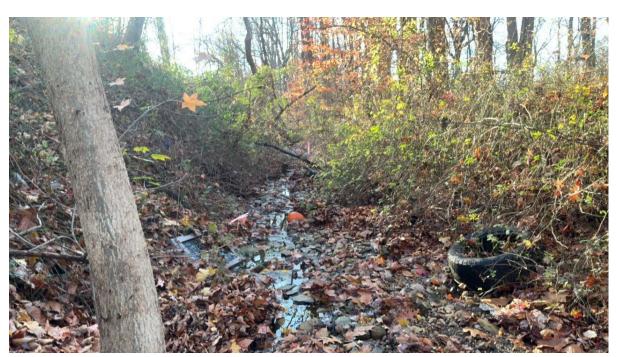
Photo 91: Facing west (downstream) along WUS-14 in the central portion of the study area. Photo taken November 26, 2024.

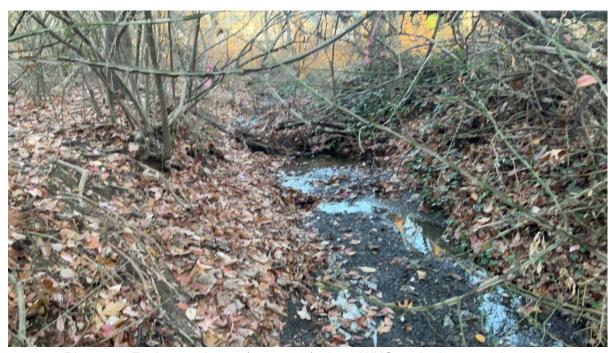
Photo 92: Facing northeast (upstream) along WUS-21 in the central portion of the study area. Photo taken November 26, 2024.

Waters of the U.S. 21 (WUS-21) is an intermittent UNT to Neshaminy Creek (Cowardin classification = R4SB4) that generally flows in a westerly direction towards its confluence with WUS-14 on the eastern side of West Interchange Road (see **Photo 92** in **Appendix D**). The average stream width was approximately 5 to 6 feet and water depth was generally 1 to 3 inches. Observed substrate consisted primarily of silt/sand, gravel, and sparse cobble. Bank heights averaged 2 to 4 feet and were moderately incised, and the riparian area consisted of a mix of trees and shrubs.
